CODE LINK

STATE OF OREGON • BUILDING CODES DIVISION

MAY/JUNE 1999

Roof, deck, and overflow drain connections

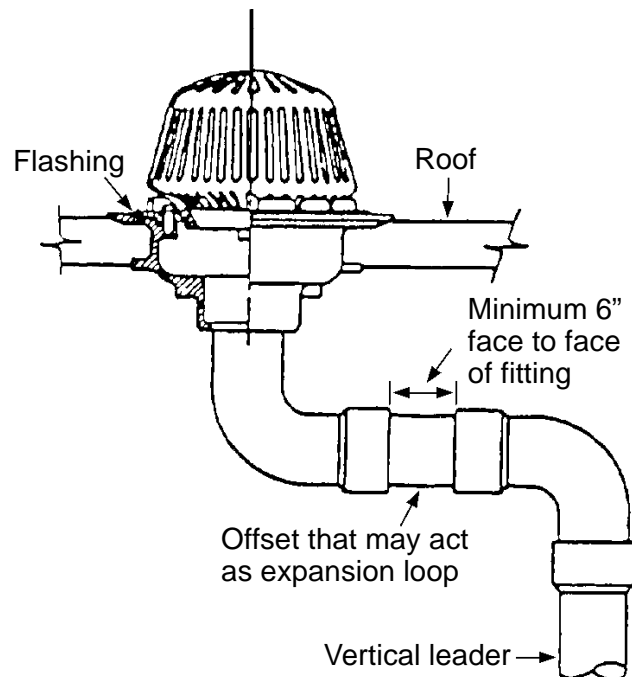
The following illustration shows an “approved swing joint” under both the codes. It is important to note that the minimum 6-inch measurement, from the face of the first fit-

What is not clear in this code section is the definition of an “approved swing joint.” Neither code defines “swing joint.” Many manufacturers of roof, deck, and overflow drains recommend their products be installed with manufactured expansion joints. In fact, many manufacturers provide their product with such a joint as an integral part of the drain assembly. Obviously, these products meet the code provisions. Products installed without the expansion joints must be installed with an “approved swing joint.”

overflow drains should not be confused with the old-style double-swing joint often used in hydronic and steam piping to allow movement in two directions and relieve the strain on rigid screwed-steel piping caused by thermal expansion and contraction. This code provision is intended to allow very limited up-and-down movement with the expansion and contraction of the roof itself.
